DEPARTMENT OF ENVIRONMENTAL PROTECTION MONTGOMERY COUNTY, MARYLAND

Watershed Restoration FACT SHEET

Woodlawn Stream Restoration

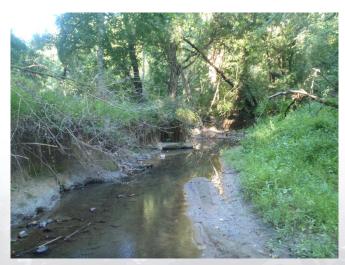
The Northwest Branch - Right Fork (Woodlawn tributary) showing streambank erosion (on left) and silt deposition (on right) prior to restoration.

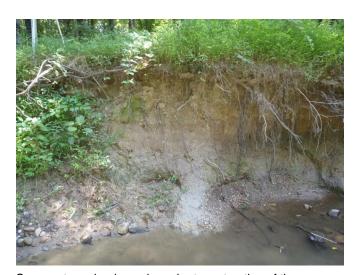
Severe streambank erosion prior to restoration of the Woodlawn tributary.
